Research Study on the Sinking Sequence of MV Estonia

Virtual demonstrator

Project No.: *SaS0603-VIES01*
Reference No.: *VIES01-RE-004-AJ*
Report Date: *18 May 2008*
Report Type: *FINAL*
Report Status: *OPEN*

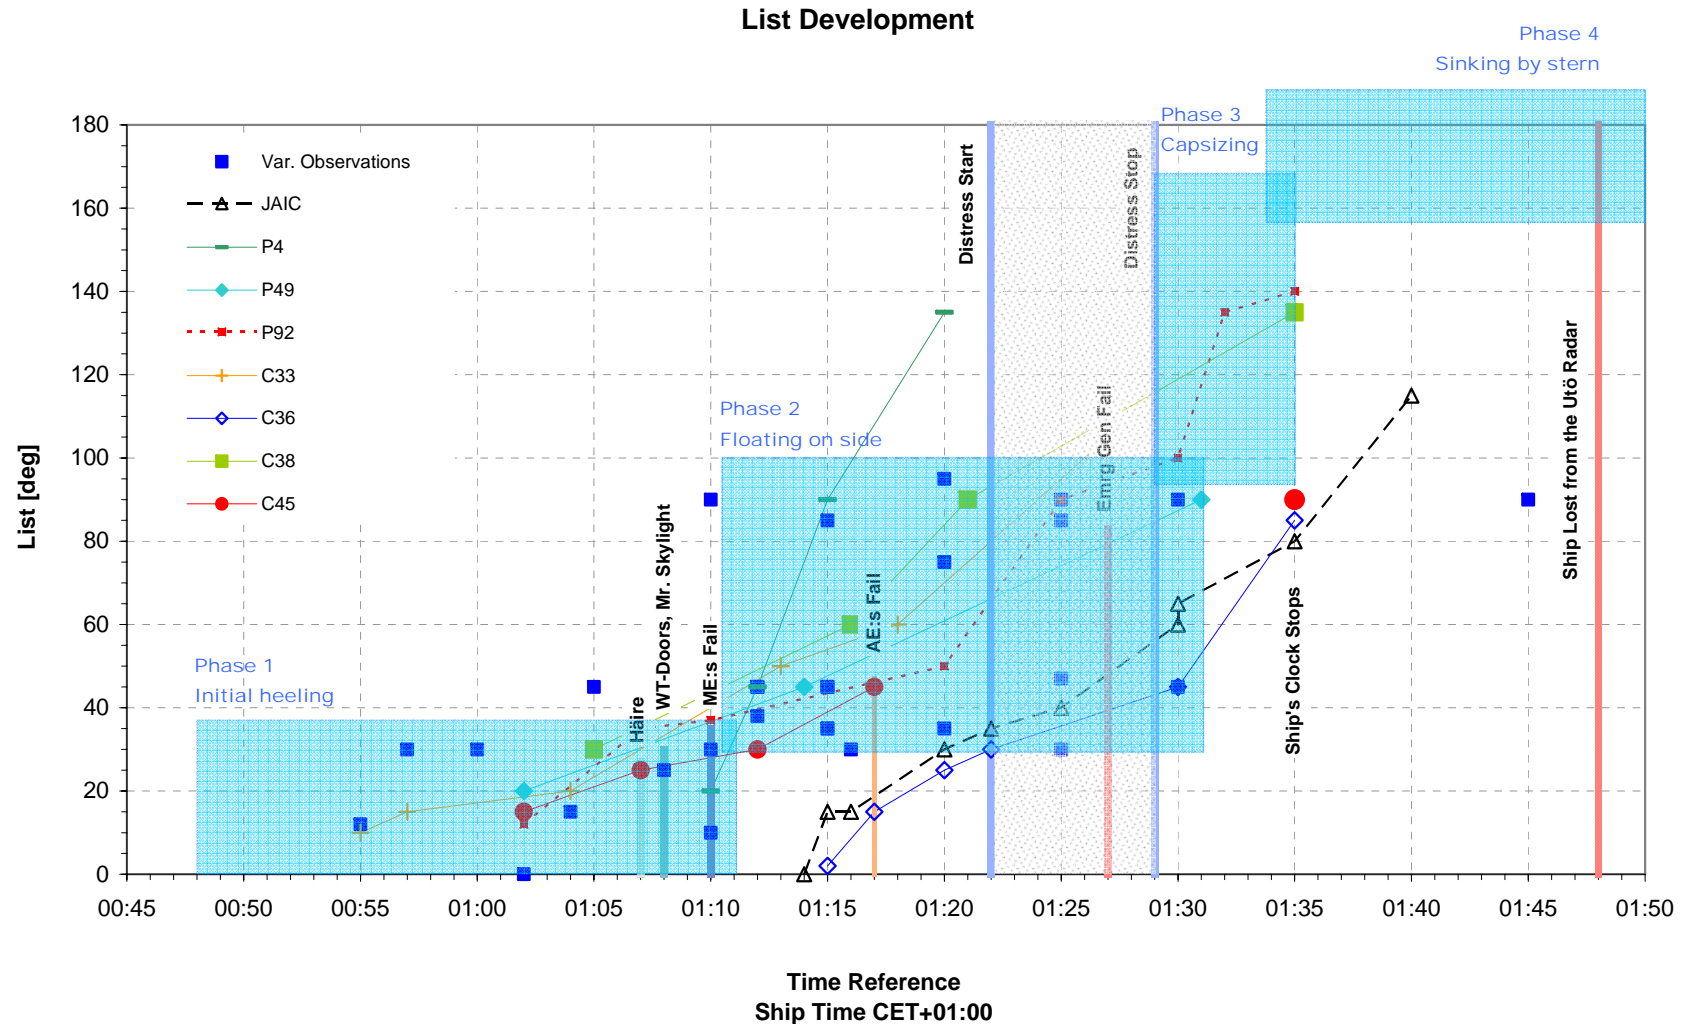
Figure 2 The sequence can be divided into the above four phases of the sinking. See [2] for summary of the sinking investigation by the SSPA consortium, and report [3] for summary of survivor's statements.

Phase 1 Initial heeling

Unobstructed inflow of water on the car deck.

Phase 2 Floating on side

Side windows withstood considerable pressure, 5-10m. Some windows possibly never broke, as the accommodation spaces flooded. Possibly, water on the car deck reached centre casing and started flooding down to D 0/1.

Phase 3 Capsizing

After ship heels to 60-80deg, capsizing within 3-5 minutes is inevitable.

Phase 4 Sinking by stern

After capsize (heel 170-180deg) the ship starts sinking by stern. Water floods spaces in D0/1 through centre casing, possibly through D4. Sinking within 10-15 minutes is possible.

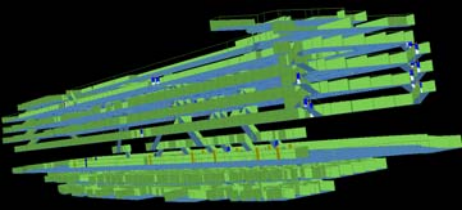
<p>Excessive amounts of water entered the car deck causing rapid heel development at every wave dive.</p>

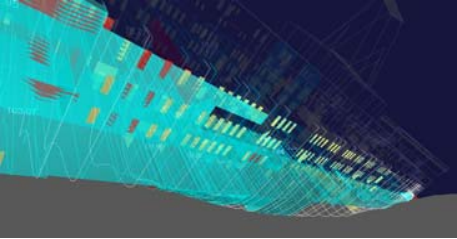
Deck 4 becomes submerged, but windows do not break instantly. The buoyancy of accommodation Decks 4, 5 and 6 supports the vessel.

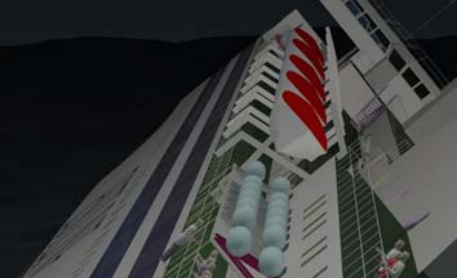
<p>Some windows will eventually break. Water floods into Deck 4 and above. Due to water ingress into the accommodation, the sea pressure on windows is compensated. Only few windows break. In the meantime, water floods to machinery spaces in Deck 0/1 through the side ventilation access.</p>
Clip 11

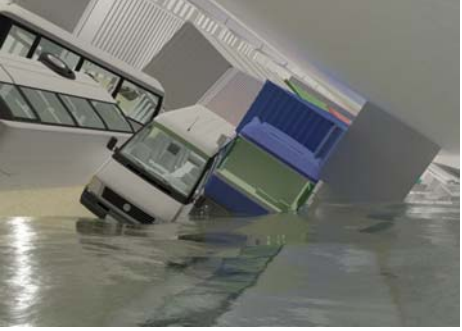
<p>As the accommodation decks support temporarily the vessel, the water in the car deck builds up, reaching centre casing at 40-50 deg angle of heel. Spaces below start also flooding from car deck, possibly aft first.</p>

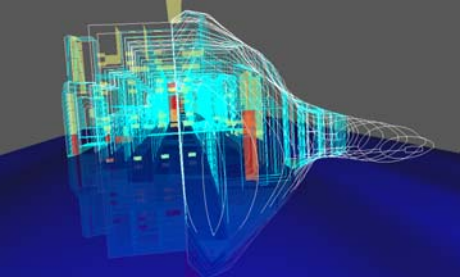
Some cargo will likely be displaced. Water continues to flood through centre casing.
Clip 14

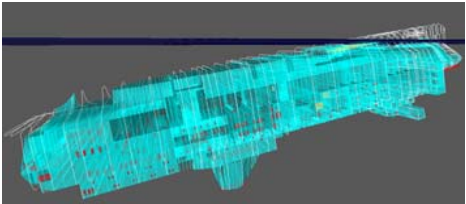
Some survivors noticed beach line developing, exacerbating impression that ship sank with the aft end first. 9 survivors from 6 different rescue rafts stated that the vessel sank by bow, possibly because some of them saw the aft, e.g. one saw propellers and another saw rudder.

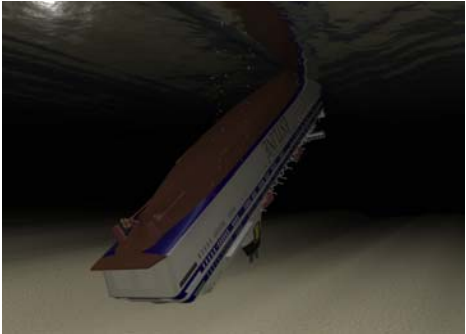
Ship continues flooding through centre casings and sinking by aft.
Clip 20
