Research Study on the Sinking Sequence of MV Estonia

Virtual demonstrator

Project No.: *SaS0603-VIES01*
Reference No.: *VIES01-RE-004-AJ*
Report Date: *18 May 2008*
Report Type: *FINAL*
Report Status: *OPEN*

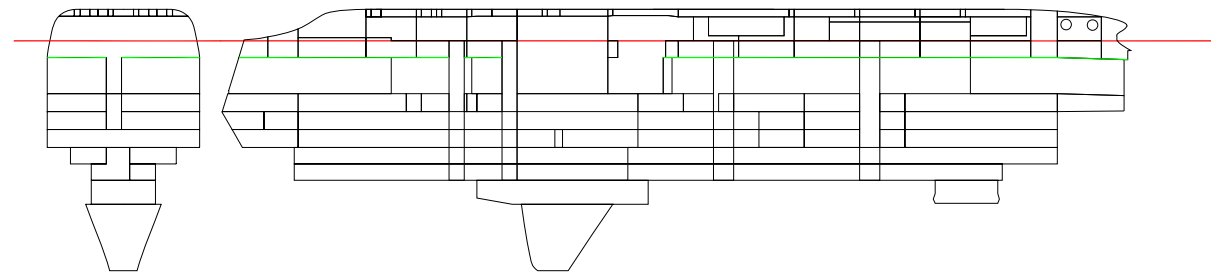
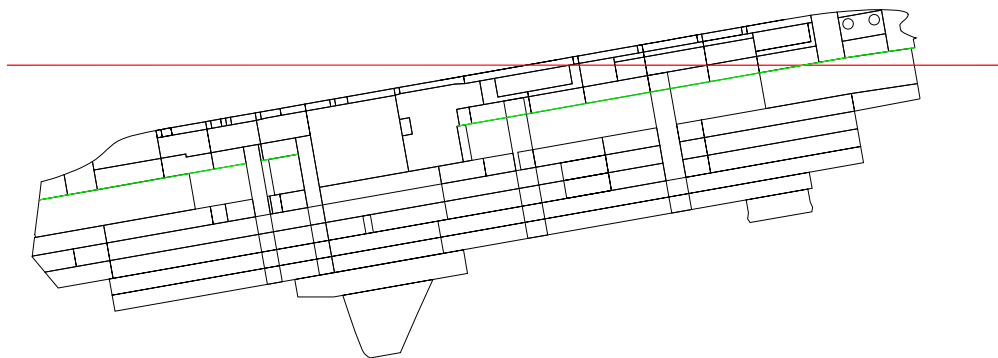
Figure 3 Sinking sequence of MV Estonia.

Phase 4 Sinking by stern

After capsize (heel 170-180deg) the ship starts sinking by stern. Water floods spaces in D0/1 through centre casing, possibly through D4. Sinking within 10-15 minutes is possible.

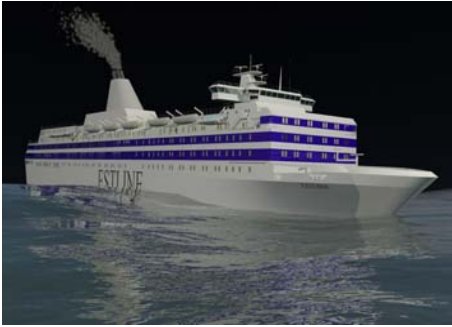
Phase 1 Initial Heeling, ca 00:47 – 01:10		
Clip 1

Ship proceeds at 14kn, port-bow quartering seas, Hs 4 - 5m.
Clip 2

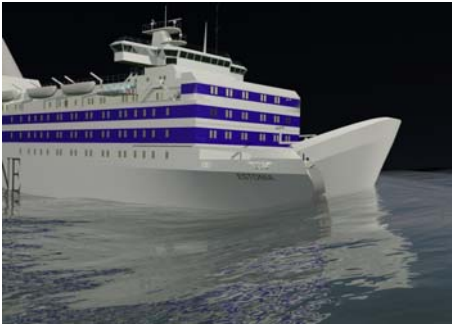
Visor suffers sea loads in excess of its load-bearing capacity. Hinges break, and visor starts breaking off its attachments. Some water starts accumulating on car deck.
Clip 3

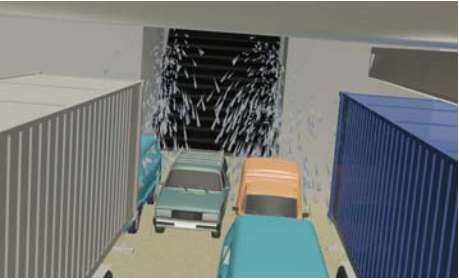
Clip 4

<p>The ECR crew observed the car deck through the monitors where they saw water pressing at sides of the ramp and water wedge forming on car deck.</p>
Clip 5

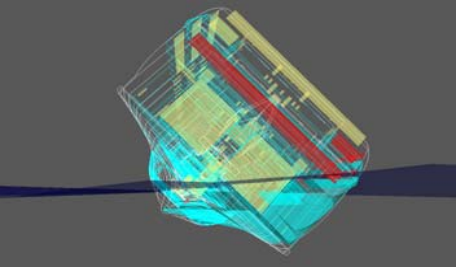
Heel angle reaches close to 35-40deg.
Phase 2 Floating on side, ca 01:10 – 01:30		
Clip 9

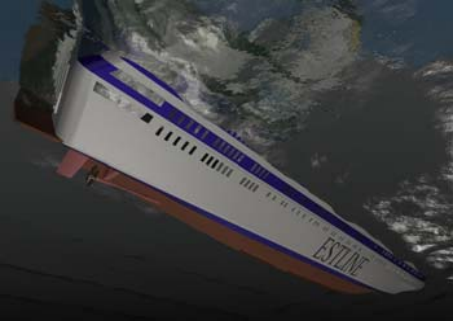
Deck 4 becomes submerged, but windows do not break instantly. The buoyancy of accommodation Decks 4, 5 and 6 supports the vessel.

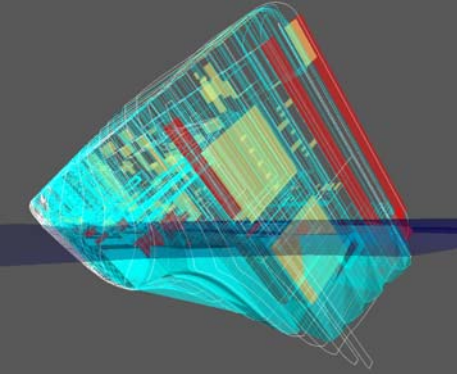
<p>As the accommodation decks support temporarily the vessel, the water in the car deck builds up, reaching centre casing at 40-50 deg angle of heel. Spaces below start also flooding from car deck, possibly aft first.</p>

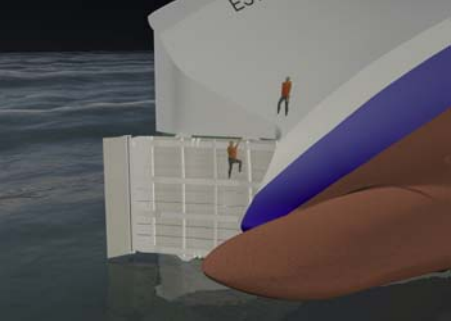
Some survivors looked for place from which to abandon the sinking ship. They reached forward part of the vessel and climbed down the ramp. They noticed deformations of the stiffening arrangement.

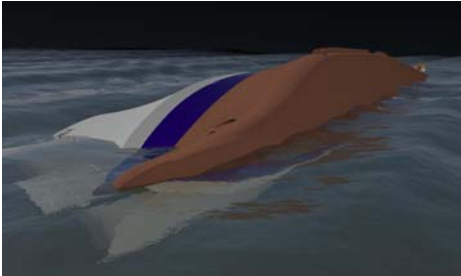
One of the survivors tried to alert nearby ships by using flash of his camera, incidentally making picture of another survivor sitting on ship's bilge. Ship capsized to 130-135deg.
Clip 17

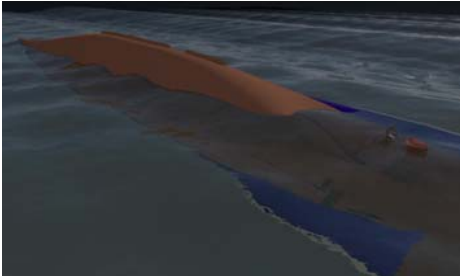
Some survivors noticed beach line developing, exacerbating impression that ship sank with the aft end first. 9 survivors from 6 different rescue rafts stated that the vessel sank by bow, possibly because some of them saw the aft, e.g. one saw propellers and another saw rudder.
